ANNUAL REPORT FOR 2008

Jeffreys Warehouse Wetland Mitigation Site
Wayne County
TIP No. R-1030AA

Prepared By:
Natural Environment Unit & Roadside Environmental Unit
North Carolina Department of Transportation
December 2008

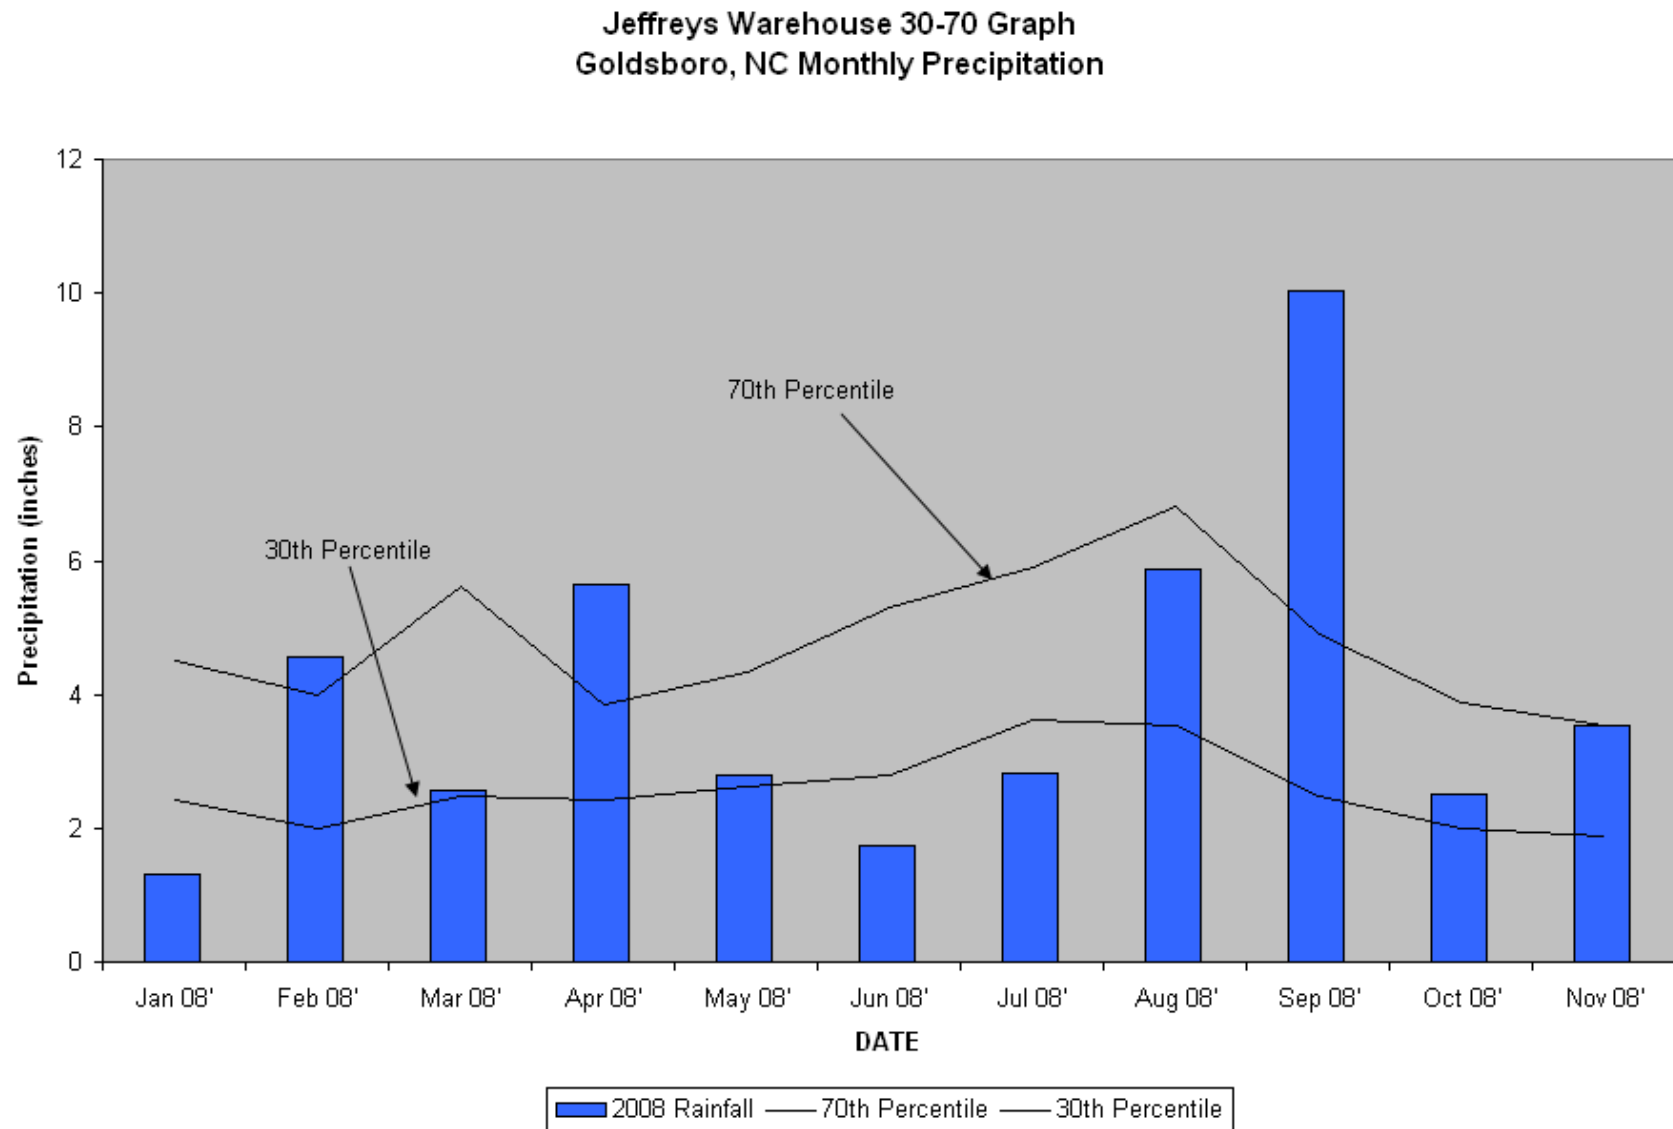
Figure 4. 30-70 Percentile Graph

Figure 4 is a comparison of monthly rainfall for the period of January through November 2008 to historical precipitation (collected between 1975 and 2008) for Goldsboro, North Carolina. This comparison gives an indication of how 2008 relates to historical data in terms of climate conditions. The NC State Climate Office provided all of the local rainfall information.

For the 2008-year, the months of February, April and September experienced above average rainfall. The months of March, May, August, October and November recorded average rainfall for the site. The months of January, June and July experienced below average rainfall. Overall, 2008 experienced an average rainfall year.
